# Analysis of tribological damages of plain bearings

In order to reduce the delay due to the failure of the plain bearings of the TE power plant Gacko, it was necessary to analyze tribological processes and damages. At TE power plant Gacko turbine K-330-240 and generator TVV 320/2 were installed. Figure 1 shows the disposition diagram of the turbogenerator. The TE power plant Gacko is disconnected from the drive after switching on the sub-frequency and grounded 100% protection of the generator stator, due to the disappearance of 400 kV and 110 kV voltages. The lubrication pumps of the turbogenerator of the DC voltage did not switch on. The sealing pumps of DC generators have been switched on by activating the automatic start of the reserve. Nine minutes after the disappearance 400 KV voltage comes and then the own power supply of power plant is turned on. Voltage 110 KV comes a minute later, after which the power supply state is normalized. During the stopping of the turbogenerator with the reduction of the vacuum, the flow of oil from gravity reservoirs to all plain bearings was activated. This paper presents a part of tribological research, damage and causes of plain bearing fai

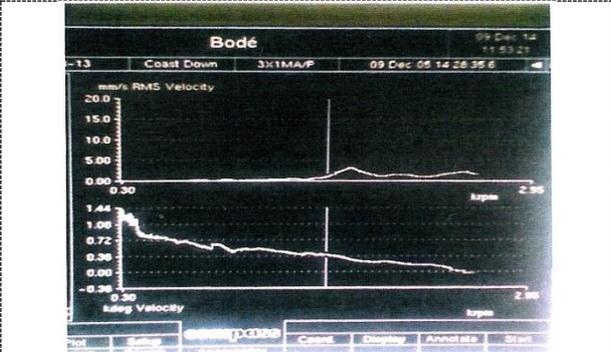
During the stopping of the turbogenerator, the temperature of the plain bearing has an increasing trend, and after a few minutes the trend of decreasing and stabilizing. After establishing a regulatory lubrication system, the temperature of the plain bearing continues with the trend of increase. The absolute vibration of the turbogenerator of plain bearing has a leap after the unit is switched off to the resonant revolutions of turbine rotor and the rotor of the aggregate.

**Figure 2.** Diagram of the basic induction frequency of vibrations in the vertical direction on the plain bearing number 7 during the normal stop of the turbogenerator.

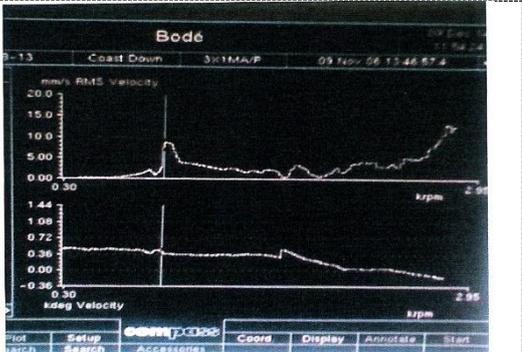
**Figure 3.** Diagram of the basic induction frequency of vibrations of zhe plain bearing number 7 during interruption.

On the plain bearing, the sensors of the relative rotor vibrations were not installed, so the rotation of the generator rotor during the emergency stop could not be monitored. The aggregate was stopped for 15 minutes, and after turning on the lubrication pumps of the turbogenerator plain bearings, the turning device was switched on to rotate the turbo generator with 3-5 rpm. After stopping the aggregate, cooling the turbine and switching off the lubrication system, the plain bearing and corresponding joint were opened. Damage of the joint is not registered. Greater damage was detected on the plain bearing. White metal was melted at bearings number 6, number 7 and number 8. On the journal of the generator rotor the rills were noticed which depths are about 2 mm in two rows with a total width of about 80 mm (figure 4). In the figure 4 traces of damage on the journal are visible, as well as belts of increased hardness (darkened areas). All damages are in the middle of the trigger journal. Circular surfaces are treated parts of the journal during the previous deviation at the places of residual cracks after the fine machining. The plain bearing journal was repaired and control of surface cracks was performed.

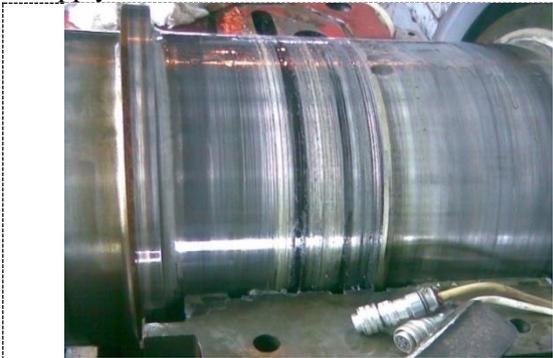
**Figure 4.** Damage of journal in the bearing zone.

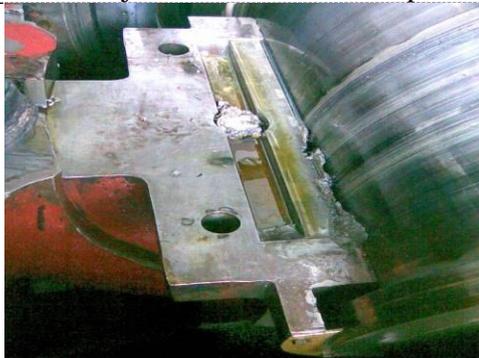
White metal deposits settled in the oil inlet on the right half (to the excitation), as can be seen in figure 5. Due to the closing of the part of the oil supply channel, partial interruption of the lubricating oil supply occurred and removal of the metal from the surface of the journal occurred in that part.

**Figure 5.** Damage of bearing brass no. 7.

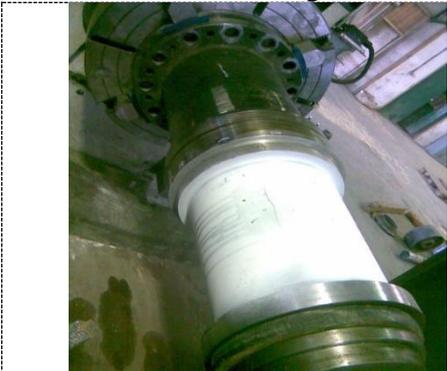
On the journal of the generator axle in the zone of segment bearing number 8 (journal diameter is  $\Phi 200$  mm) the surface was damaged and the cracks were noticed as shown in figure 6. Due to the appearance of cracks, the continuation of the rotor is unusable and a new one was made of steel 34CrNiMo6 according to the existing documentation. The adaptation of bearing brass to the bearing journal number 7 is shown in figure 7.

**Figure 6.** Damage of axle extension of the generator.

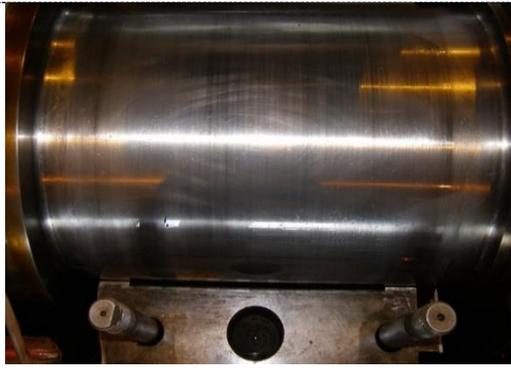
**Figure 7.** Adaptation of bearing brass to the bearing journal number 7.

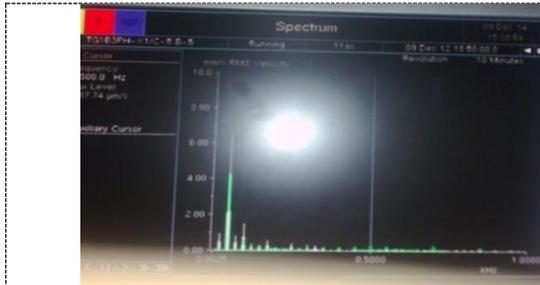
Vibration intensity of bearings number 1 and 3 of was directly dependent on the load on the block. This is clearly seen on the spectral overview of vibrations of bearing before the block power is reduced (figure 8). On the half-harmonic  $1/2X$  vibration rate is 1 mm/s, and at  $3/2X$  it is about 0.8mm/s. As the

**Figure 8.** Spectral diagram of vibration of bearing number 3 horizontally before reducing the block power.

In order to reduce the turbine's vibration level, a reduction in block power from 240-250 to 210-230 MW was carried out, i.e., the boiler was power from an electric power pump instead of turbocharging pump.

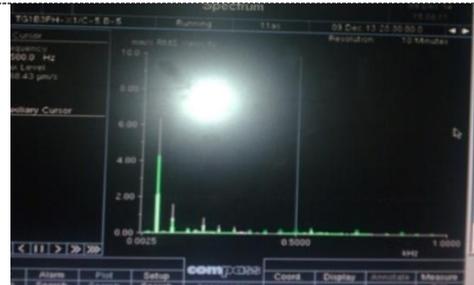
power of the block was reduced vibrations decreased, at a speed of about 7-8 mm/s to a value of 6-7 mm / s. The component of the vibration on the half-harmonic 1/2X, 3/2X, 5/2X disappeared (figure 9).

**Figure 9.** Spectral diagram of vibrations of bearing number 3 horizontally after reducing the block power.

In an electric power pump mode with a load of 210-230 MW, the vibrations of the turbines are lowered to the B class for this type of device and, with additional control limits, the block operation is further extended.

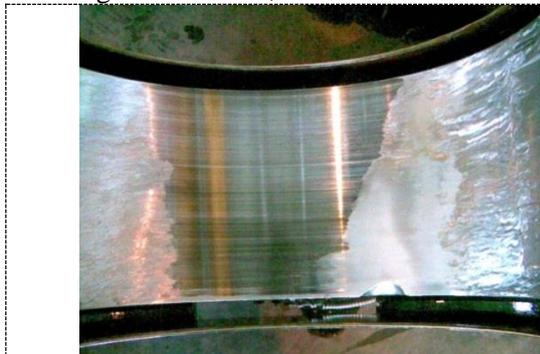
The block was stopped in order to determine the cause of the increased level of vibrations of the turbine bearings number 1 and 3. After cooling the turbine, the turbogenerator bearings were opened and an overview was performed. On the first bearing, there are visible traces of damage on the part of the white metal surface on the lower half of the insert (figure 10). The removal of white metal on the lower half of the surface of the plain bearing due to the failure of the rotor of 0.16 mm is also visible. According to the character of the damage, it is clear that it is an electro-erosion corrosion that occurs due to the breakdown of the vortex currents from the rotor to the stator part (contact surface of the bearing brass number 1). The rehabilitation consists of showering of the bearing surface, adjustments to the caliber and re-assembly.

**Figure 10.** Damage of the lower half of the bearing brass due to electro-erosion corrosion.

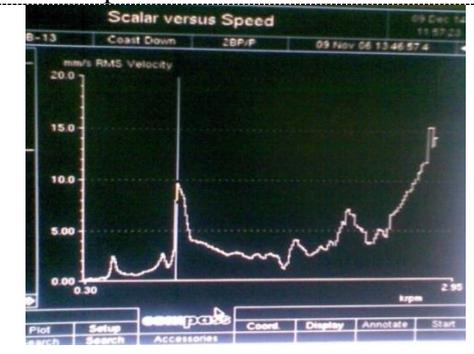
In the figure 11 the trends of vibrations of the plain bearing at the time of the turbogenerator stopping from 2950 rpm to 0 rpm are shown. They were recorded by the Compass Schenk turbogenerator control system. The second speed peak of the total vibration level up to 10 mm/s is at 900 rpm, i.e. on the critical rotational speed of the generator rotor. Based on the vibrations during the turbogenerator stopping, it can be noticed that the aggregate on the plain bearing already at a speed of 2950 rpm., immediately after switching off the block, it had a contact of the rotor with the stator part.

**Figure 11.** Diagram of the level of total vibrations on the plain bearing during stopping the turbogenerator.

Based on the analysis, it could be concluded that the resulting damages were the result of an irregular operation of the emergency oil reservoir. By analyzing the data from the figure of the control system, as well as the vibration monitoring system of the turbogenerator, it can be ascertained:

- the vibration of the plain bearing has increased sharply to 15 mm/s for 50 seconds after the unit has been switched off after the critical revolutions of the generator have passed
- the mentioned vibrations initiate on the contact of the rotor with the stator part of the plain bearing
- it is obvious that there are reasons that influence the shutdown regime of the generator rotor when problems arise due to the disappearance of the forced lubrication system.
