HOW COULD BE PREVENTED HIGH VOLTAGE DISCONNECTING SWITCHES' COLAPSE IN EXPLOITATION.

Key words: Ceramics Post Insulators, High Voltage Switches, cracks, damages, economic effects.

1. 110KV HIGH VOLTAGE SWITCHES SCHEME, REPORTED ACCIDENTS AND SOME CAUSES OF THEIR COLAPSE IN EXPLOITATION.

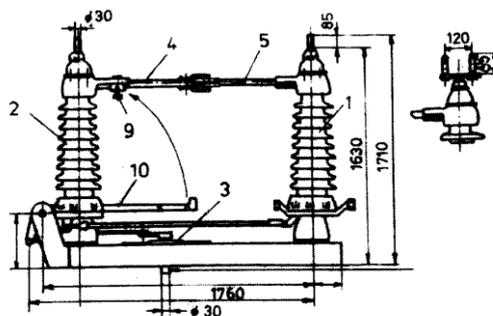
Fig.1.1. Scheme of 110 kV Rotative High Switch.

Ceramic Insulators 1 , 2 can swivel, turning round with 90° under the action of a mechanic or an electrical device 3 . On the rods 4 and 5 , are set electrical contacts 6 ,7 and 8. They are mounted in a vertical position, on a metallic frame, on which are also set up all mechanic action devices.

Ceramic Post Insulators which are investigated in this work, are incorporated in the 110KV High Voltage Switches Construction. These Switches enable the horizontal blades opening, having a 110KV nominal Voltage and nominal currents of 1250 – 1600 – 2000 A. These Switches present only a monopole construction. Engineering scheme of such a Rotative Switch is presented in Fig.1.1 and its connecting pole is enclosed.

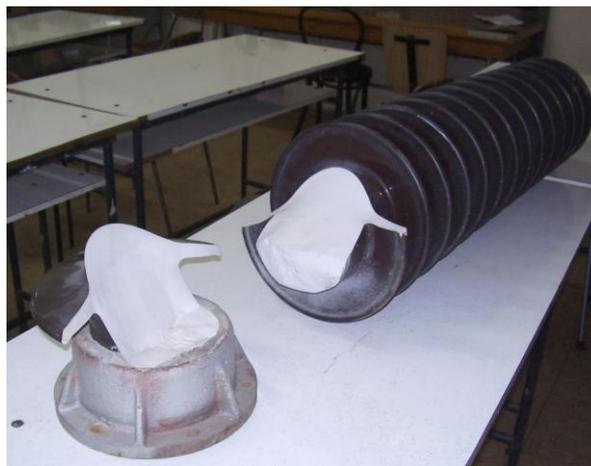
Fig.1.2. Ceramic Insulator broken from the metallic bottom support

Electrical field events collected during a long period, 01.01.2005 – 01.06.2007 showed that, some of these Ceramic Post Insulators have been broken in exploitation, both at the upper metallic cup and at the bottom metallic support of the ceramic rotating insulators. In fig.1.2. is presented such an accident. These accidents were traced out like follows:

The brakes were located at the upper metallic cup, most of them and also at the bottom metallic support.

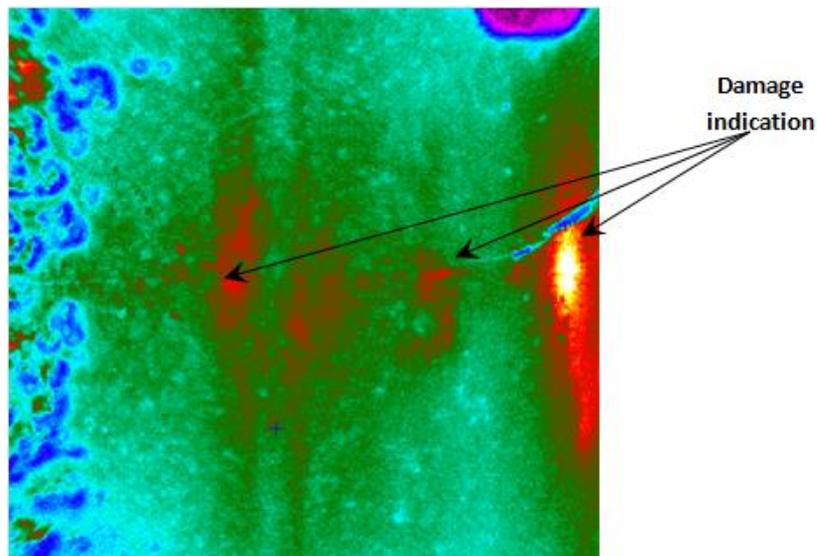
Fig.2.1. Small and large cracks in the Ceramics Post Insulators.

- Ceramics Post Insulators with no defects, which can go on to be used without problems ;
- Ceramics Post Insulators containning one or two small cracks localized at the base of these, which can be maintained in use, but controlling the craks developing periodically ;
- Ceramics Post Insulators containning deadly defects, like small and large cracks (Fig.2.1.), penetrated cracks, which must be taken off from their use, in the structure of 110 KV High Voltage Disconnecting Switches.

- Some of the investigated Ceramics Insulators presents original defects like: cracks, pores, lack of material, thermic points ;
- Thermic Points localized at the base of some Insulators, may generate a „ V „ small slit, which in time, during exploitation, may penetrate through the material, to the surface ;
- During Investigation of the Ceramics Post Insulators, the Disconnecting Switcher must be put off the function

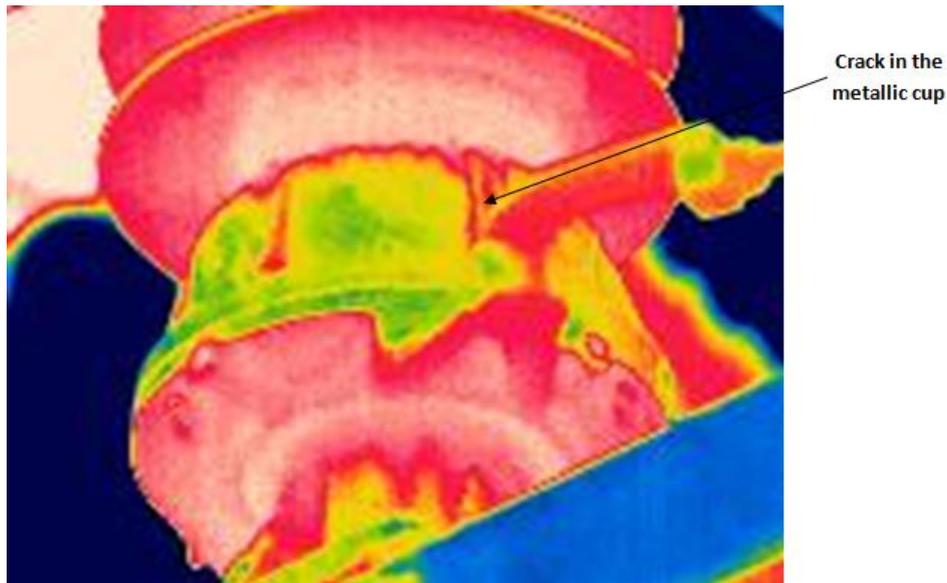
Fig.2.2. Ceramics Insulator with a large Crack in Metallic Cup.

- Ceramics Insulators with a large crack in the Metallic Cup, as in Fig.2.2;
- Penetrated Cracks to the Base of the Ceramics Insulator, as in Fig.2.3;
- Small and large Cracks in the Ceramics Insulator Body.

All these defects have been confirmed by direct and optical examination.

So we may conclude that The Thermographic in infra-red Method is appropriate to put in evidence the Ceramic Post Insulators Damages, by Direct Control, without taking off the use of Disconnecting Switches. In fact this Passive method does complete examination performed through the Active Method.

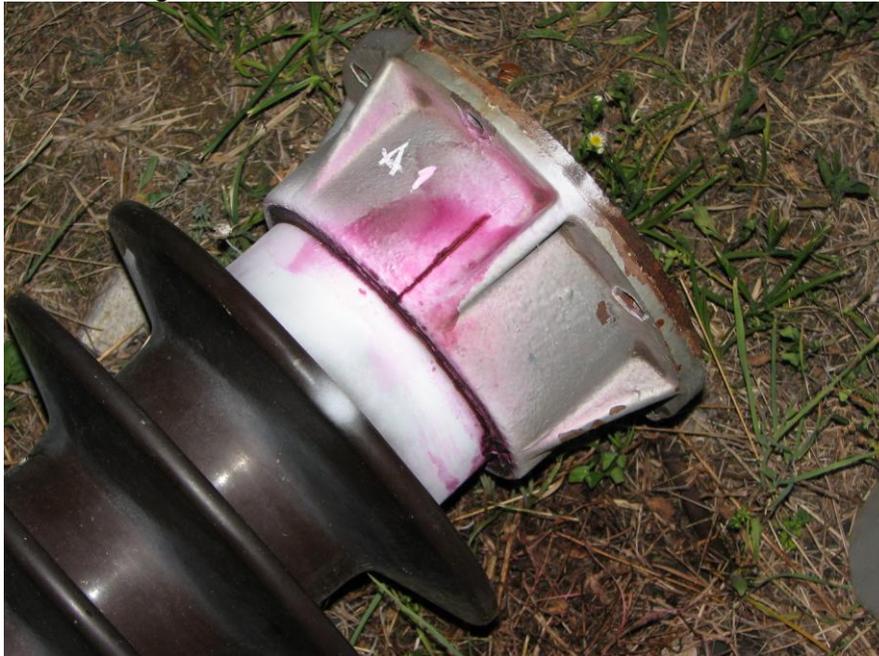
Fig.2.4. Longitudinal fissure in the metallic cup.

In the following photos are presented some very dangerous defects localized on these zones. Through this investigations we tried to guess if the cracks founded in the metallic cups, could have any influence on Ceramics Insulator's Body deterioration.

Certainly, such a supposition is not a rule. The metallic cups cracking might not influence ceramic's body splitting and vice-versa. There have been performed analyses to discover the propagation process of the cracks , from the core to the surface of the ceramic body. Some of the inspection remarks are presented next, on the following images in Fig.2.4. and Fig.2.5.

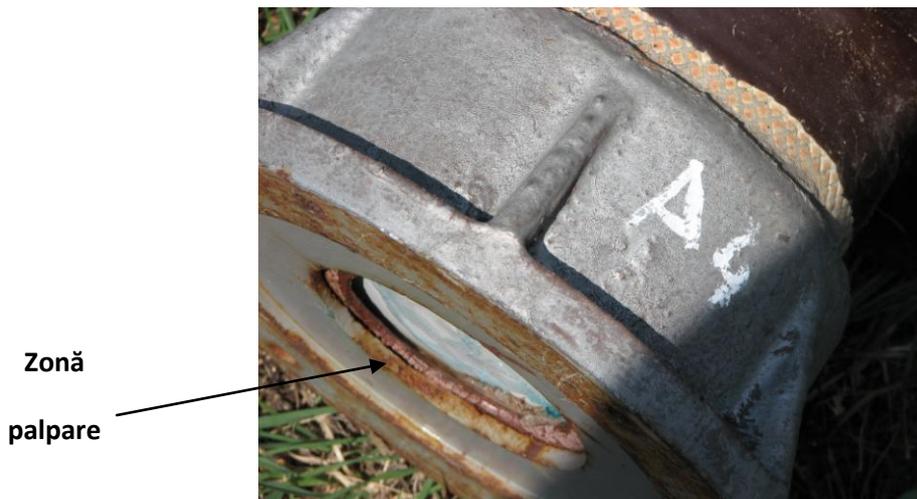
Fig.2.6. Examination zone on the base of Ceramic Post Insulator.

There have been used “normal palpates “, initially applied on the exterior surface of the Ceramic Body on both important zones, the one between inferior cup and the first row of the ceramics body and the one between superior cup and the last row of ceramic material. No have been found discontinuities. In the next phase, there have been examined the inferior zone, through the metallic cup hole, as is presented in Fig.2.6 .

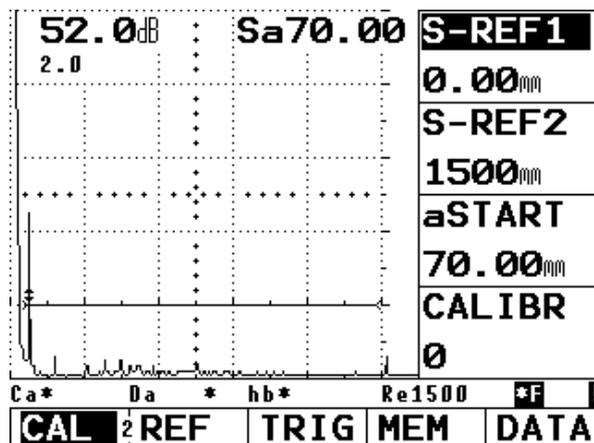
Fig. 2.7. Discontinuity indication at 70 mm.

There have been found “discontinuities indication”, signalized in some diagrams (DAC –Distance Amplitude Curve) like in in Fig.2.7. ,most of them at the bottom part of the ceramic body, covered by metallic cup, but also along the ceramic body and at the top of it.

- Taking account that 30 – 40 % of the Ceramic Post Insulators investigated, have presented “discontinuities indication” of some possible defects, this method is valuable to prevent accidental damages of the disconnecting switches;
