## **LABORATORY PROCEEDINGS TO EXAMINE THE FUNCTIONAL STATE OF THE 110KV DISCONNECTING SWITCHES**

**Abstract:** This work presents the most convenient Laboratory Proceedings, that might be used to examine the functional state of the Ceramics Cylindrical Insulators, which are incorporated in the 110 KV High Voltage Disconnecting Switches. During years of exploitation in the electric fields, some of these Ceramics Post Insulators are affected by cracks, very small in the first stage, but becoming deep and large in time. Besides, other defects like small cracks, pores, lack of material, thermic points etc might certainly be at the origin of Ceramics Cylindrical Post Insulators Damage. It is, of course, more convenient and economic to prevent their breaking in current exploitation. Doing this, we can avoid some very dangerous accidents and save a lot of money and troubles. The usual laboratory proceedings to investigate functional state of Ceramics Cylindrical Insulators are:

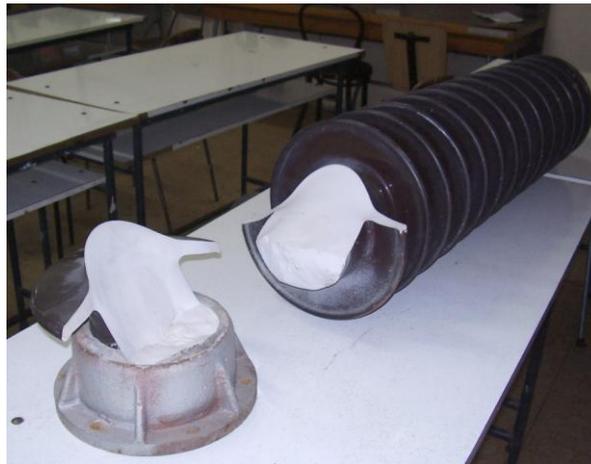
**Fig. 2.1. Ceramic Insulator broken from the metallic bottom support**

upper metallic cup and at the bottom metallic support of the ceramic rotating insulators. In fig.2.1 is presented such an accident. These accidents were traced out like follows:

The brakes were located at the upper metallic cup, most of them and also at the bottom metallic support.

Reported breakings of the Ceramic Post Insulators, used in 110KV High Voltage Switches, are the action result of one or more of the following causes:

1. Metallic Parts cracking during the winter time, when the protection coat of paint falls and the water is absorbed by the bounding cement. Freeze of the condensed/ rainfall water slipped between Ceramic Insulators and its metallic parts, destroy metallic parts.

2. During winter time, due to the hoar frost and water frost, the weight of electric bounding conductor, may increase very much, exceeding the maximum load of 4000 N, which may result in Bending Moment overtaking.

3. Rigid electric rod conductors, inadequate used in exploitation, may become stiff and lead to loads increasing;
4. Armed operation of the Ceramic Insulators with their metallic parts, were made unsuitable, sometimes. Bounding cement layer, in some cases, were not symmetrical distributed, and there were found important excentricities. This fault is called „running core”.

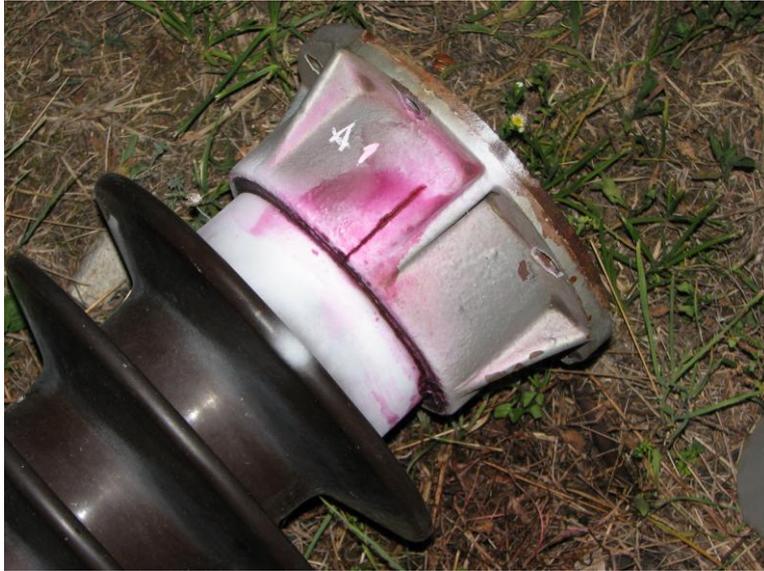
*Fig.4.4. Longitudinal fissure in the metallic cup.*

There were inspected both important zones, the one between inferior cup and the first row of the ceramics body and the one between superior cup and the last row of ceramics material.

In the following photos are presented some very dangerous defects localized on these zones. Through this investigations we tried to guess if the cracks founded in the metallic cups, could have any influence on Ceramics Insulator’s Body deterioration.

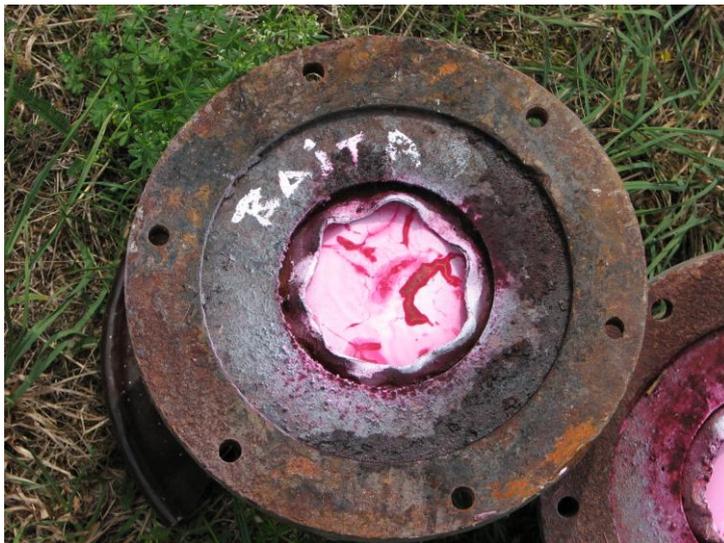
*Fig.4.5 Deep crack on the base of the ceramics body.*

Certainly, such a supposition is not a rule. The metallic cups cracking might not influence ceramic’s body splitting and vice-versa. There have been performed analyses to discover the propagation process of the cracks , from the core to the surface of the ceramic body. Some of the inspection remarks are presented next, on the following images in Fig.4.5 and Fig.4.6.
