# CONSTRUCTION DEFECTS IN THE SUBSEQUENT INSULATION OF PANEL BUILDINGS

**Abstract**—This article is intended to highlight elementary construction defects occurring during subsequent thermal insulation which would considerably improve the energy properties of buildings. The previously planned fifty-year life cycle of large-panel building structures may significantly improve after the insulation of the facade. Therefore, it is desirable to observe the regulations in every detail and execute the renovation in a professional manner.

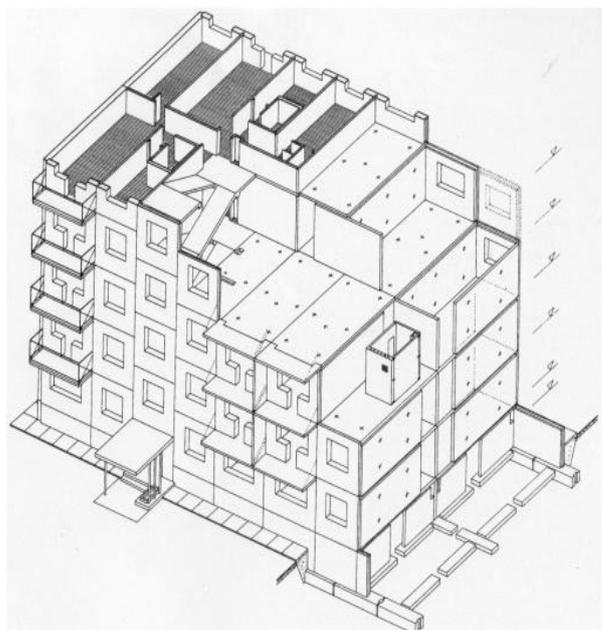
Fig.1 Panel building  
(Source: [5])

Panel buildings consist of sheet-like frameworks, which are normally a storey high and the size of a room. These modules may be turned into a supporting frame by pouring concrete into them along the edges at the construction site.

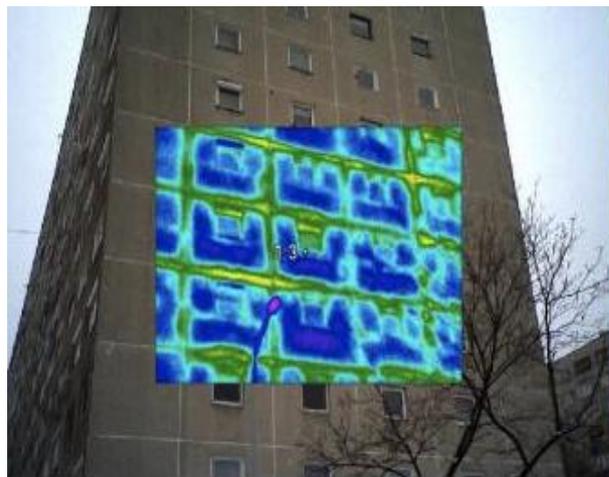
Fig.3 Thermal image of a panel building  
 (Source: [6.]

Most of the buildings are in a really bad condition because of poor construction standards and are in need of fundamental (**non-static**) renovation. Energy loss is quite high in the case of panel buildings. This is well-

illustrated by the thermal image in Fig.3.

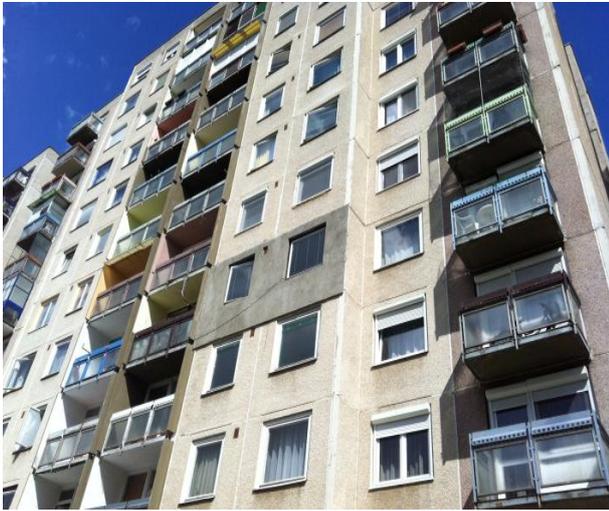
Fig. 4 Custom subsequent facade insulation  
(Source: press photo)

During the construction (1950-1978), such buildings were built, as a result of unrealistically low energy prices and the lack of adequate materials, which lack low level heating control, or it is rudimentary, and where billing or the measuring of consumption was not based on individual consumption, and, what is more, it is still not. Especially in the case of panel buildings, this results in a huge waste of energy. A certain wave of insulating buildings started in Hungary to insulate the corners, decrease the impact of thermal bridges and to help improve low thermal comfort. The insulation of the facade of a building is like football in Hungary – everybody seems to be an expert at it. Without the professional background and knowledge such solutions came to exist, which we can come across every day. Fig.4 shows such solutions very well.

The tenants and contractors who use such solutions may not even suspect that, as a result of their work, they cause further problems to the neighbors and even themselves. Sooner or later problems generated and accumulated by thermal bridges will begin to occur even on walls that had no mold problems before.

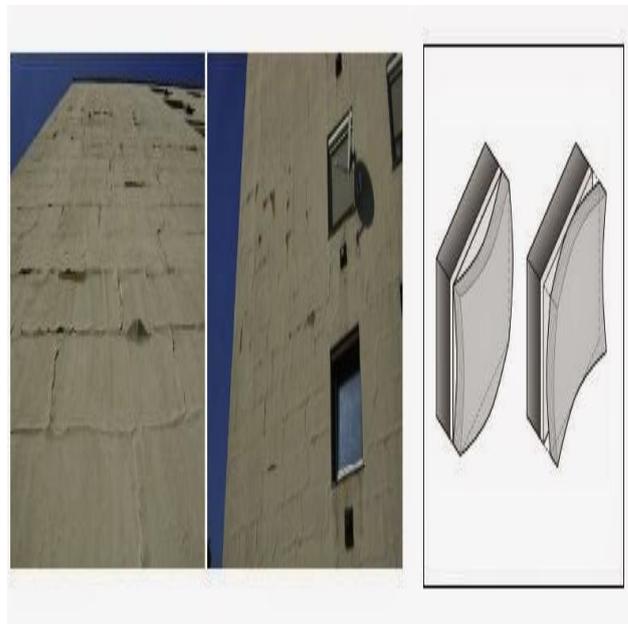
Fig. 5 Working levels

The other solution is the application of a suspension bridge, which admittedly was not intended for this purpose, but contractors often tend to choose this option still for its easy rentability. It must be noted though that only personnel who have the required licenses may operate it. Experience has shown that it doesn't allow for accurate work. Dust and the formation of stains on the facade show this. In order for workers to be able to keep within the vertical and horizontal planes, it must be continually checked and evenness must be provided. In this case, this is always limited to the size of the basket/bridge. Working on it is like working on a moving swing. Fig.5 shows working levels used during construction and the stains and sediment which have appeared on the barely half-year old facade.

placing one pane over the other, which may cause a chimney effect. The result of this is best proved by the fire in Miskolc (Although, it must be noted, this was not the cause of the fire but it accelerated its spreading). Due to the incorrect adhesive bonding, panes of insulation show fast and flexible deformation as a result of rising morning temperatures which follow the drop in temperature at dawn. The mattress effect is shown in Fig.5. The real-life effect can be seen. [4]
