ENGINEERING METHODS TO MENTAIN IN SERVICE HIGH VOLTAGE DISCONNECTING SWITCHES AND PREVENT THEIR ACCIDENTAL DAMAGE

CARP Victor

Universitatea din Oradea, victordcarp@yahoo.com

ANNALS of the ORADEA UNIVERSITY. Fascicle of Management and Technological Engineering, Volume IX (XIX), 2010, NR2

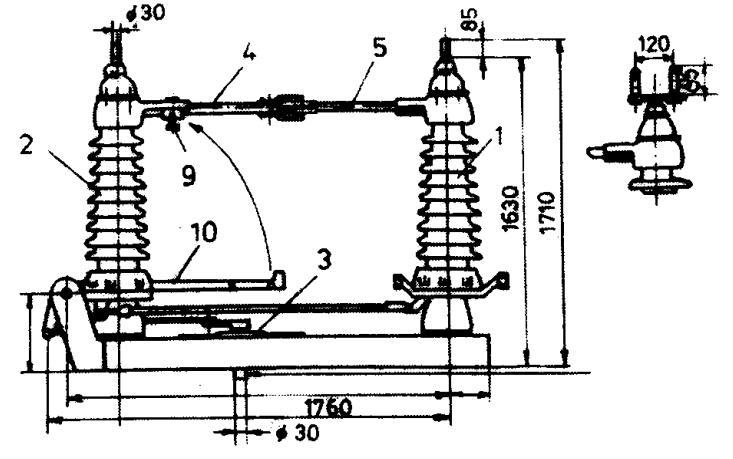
Fig. 1.1. - Schema of an 110 kV Rotative High Switch

Ceramic Post Insulators which are studied in this scientific research, take part in the 110KV High Voltage Switches Construction. These Switches enable the horizontal blades opening, having a 110KV nominal Voltage and nominal currents of 1250 – 1600 – 2000 A. These Switches present only a monopole construction. Engineering schema of such a Rotative Switch is presented in Fig.1.1 and its connecting pole is enclosed.

Ceramic Insulators 1, 2 can swivel, turning round with 90° under the action of a mechanic or an electrical device 3. On the rods 4 and 5, are set electrical contacts 6,7 and 8, as they are presented in fig. 1.2..

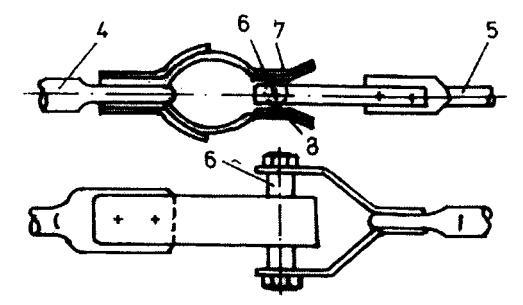
Fig. 1.2. – Electrical contacts of the switch.

They are mounted in a vertical position, on a metallic frame, on which are also set up all mechanic action devices. Manufacturer " Electroputere S.A " – provides all required needs

Accidental Switch Rods collision, in the Electric Contacts Junction, setting up by a Contact Cylinder and a Contact Muff.

3. Staff on duty should avoid accidental Switch Rods collision, in the Electric Contact Junctions, checking up the good state of function of Contact Cylinder and its Contact Muff.

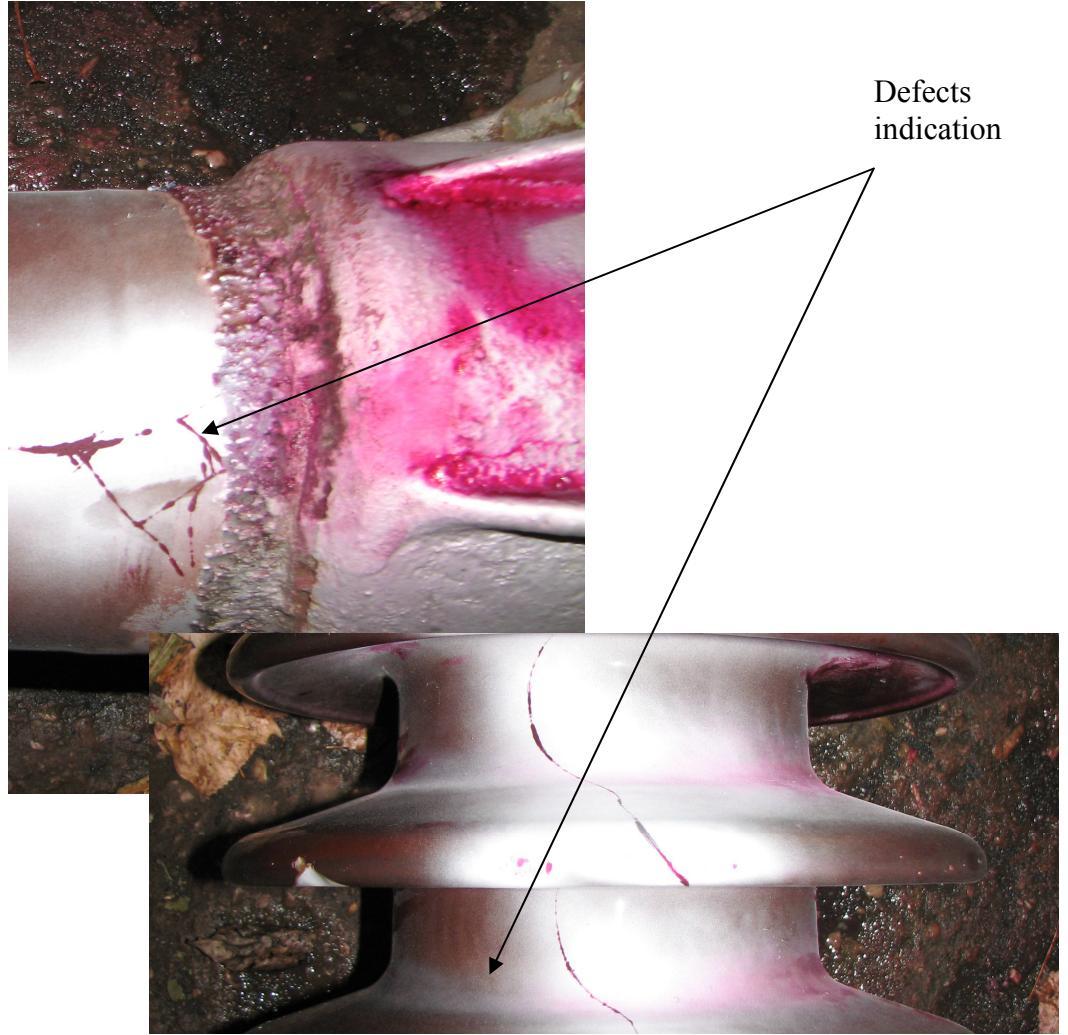
Electrical field events collected during a long period, 01.01.2005 - 01.06. 2006 showed that, some of these Ceramic Post Insulators have been broken in exploitation, both at the upper metallic cup and at the bottom metallic support of the ceramic rotating insulators. These accidents were traced out like follows:

The brakes were located at the upper metallic cup, most of them and also at the bottom metallic support.

Fig. 2.1. Cracks and boundary cement distruction:

Metallic Parts craking during the winter time, when the protection coat of paint falls and the water is absorbed by the bounding cement. Freeze of the condensed/ rainfall water sliped between Ceramic Insulators and its metallic parts, the upper cup and the bottom support, or absorbed by the bounding cement, involves an important volume increasing of iced water. Consequently, microscopic cracks appears both into the metallic parts and to Ceramic Post Insulator. In time, these cracks become larger and larger . There were cases when such fissured metallic cups fell themself from the Ceramic Insulator.

Armed operation of the Ceramic Insulators with their metallic parts, were made unsuitable, sometimes. Bounding cement layer, in some cases, were not symmetrical distributed, and there were found important excentricities. This fault is called "running core".

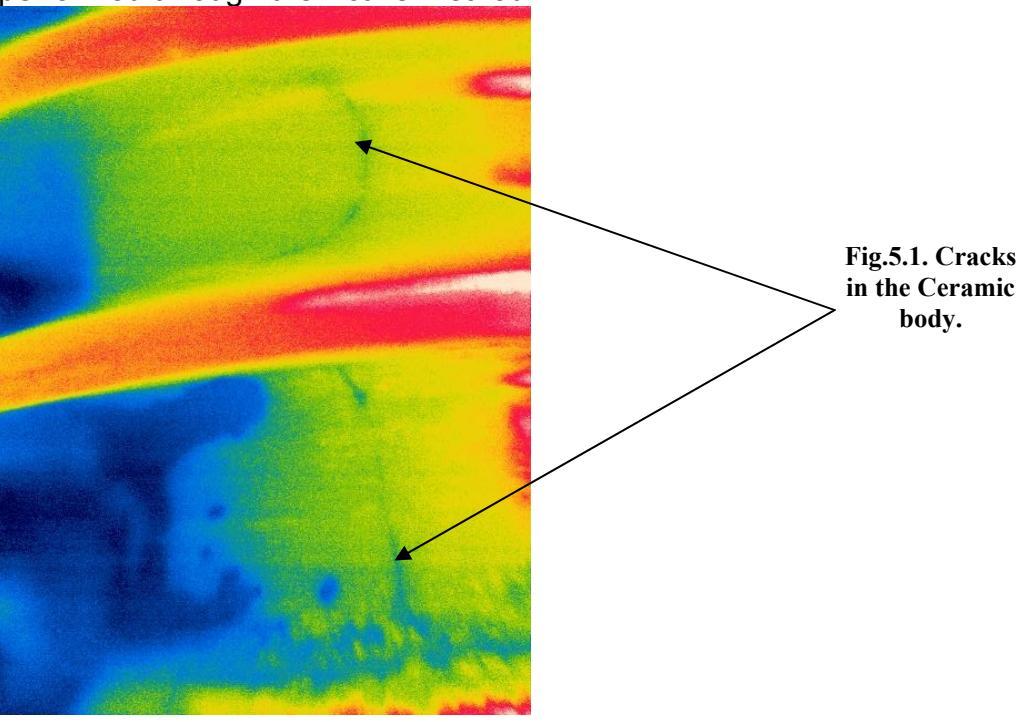
The Passive Method has only a Thermocamera THERMOCAM SC 640 that uses the inner warm of the ceramic material. This method is appropriate to put in evidence the Ceramic Post Insulators Damages, by Direct Control, without taking off the use of Disconnecting Switches, Fig.5.1. In fact this Passive method does complete examination performed through the Active Method.

Thermography in infra-red by impulses, the Active Method, involves an adequate system of thermography apparatus, containing a ThermoCAM PM 350, a Warm System by Electric Lamps, an appropriate computer, able to create a thermic image which can be disply into a spectral range. So that, this method is suitable for a laboratory study.
